**HOME**  
report

SINGLE SURVEY  
ENERGY REPORT  
PROPERTY QUESTIONNAIRE  
VALUATION REPORT

# Single Survey

| <b>Property Address</b> | 16 Clova Crescent Nairn IV12 4TE |

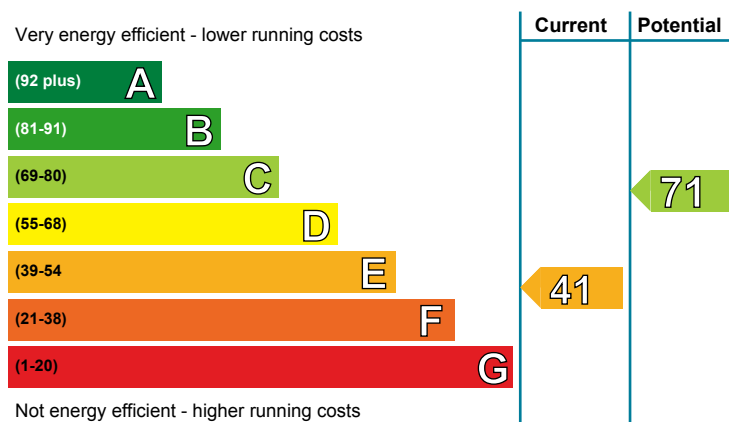
## Energy Efficiency Rating

This graph shows the current efficiency of your home, taking into account both energy efficiency and fuel costs. The higher this rating, the lower your fuel bills are likely to be.

The potential rating shows the effect of undertaking all of the improvement measures listed within your recommendations report.

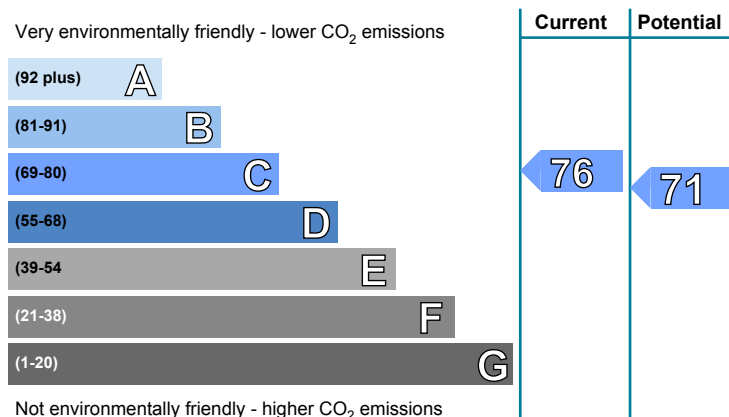
## Environmental Impact (CO<sub>2</sub>) Rating

This graph shows the effect of your home on the environment in terms of carbon dioxide (CO<sub>2</sub>) emissions. The higher the rating, the less impact it has on the environment.
