Home Report

44 B Baron Taylor Street Inverness IV1 1QG

single survey

Property address	44 B Baron Taylor Street
. ,	Inverness
	IV1 1QG

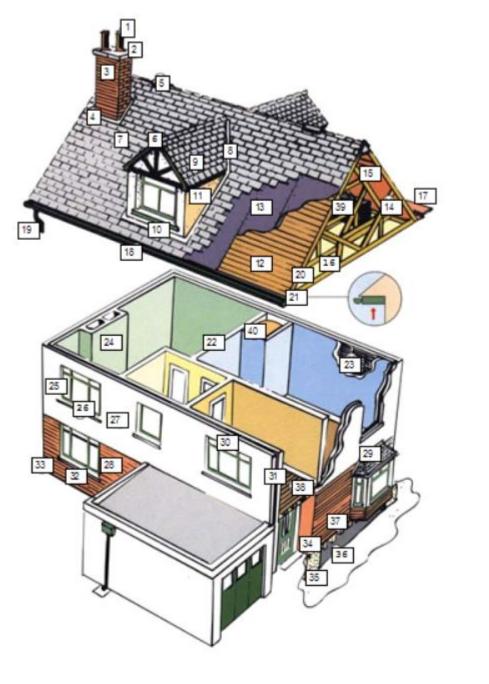
Sectional Diagram showing elements of a typical house

Reference may be made in this report to some or all of the above component parts of the property. This diagram may assist you in locating and understanding these items.

Parapet gutter Eaves guttering Rainwater downpipe Verge boards / skews Soffit boards Partition wall Lath / plaster Lath / plaster Chimney breast Window pointing Window sills Rendering Brickwork / pointing Bay window Lintels Cavity walls / wall ties Subfloor ventilator Damp proof course Base course Foundations Solum Floor joists Water tank 	15	Collar
18Eaves guttering19Rainwater downpipe20Verge boards / skews21Soffit boards22Partition wall23Lath / plaster24Chimney breast25Window pointing26Window sills27Rendering28Brickwork / pointing29Bay window30Lintels31Cavity walls / wall ties32Subfloor ventilator33Damp proof course34Base course35Foundations36Solum37Floor joists38Floorboards39Water tank		Insulation
19Rainwater downpipe20Verge boards / skews21Soffit boards22Partition wall23Lath / plaster24Chimney breast25Window pointing26Window sills27Rendering28Brickwork / pointing29Bay window30Lintels31Cavity walls / wall ties32Subfloor ventilator33Damp proof course34Base course35Foundations36Solum37Floor joists38Floorboards39Water tank	17
