CHALLTUINN ERROGIE

Home Report

CHALLTUINN, ERROGIE, INVERNESS, IV2 6UH

Scottish Single Survey

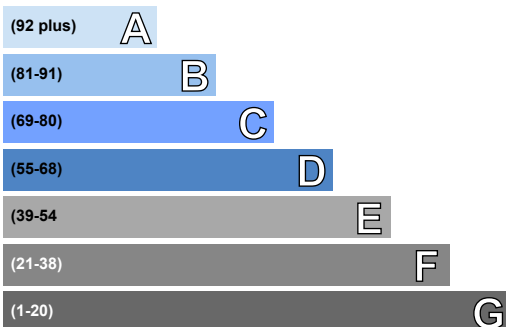
Very environmentally friendly - lower CO₂ emissions

Not environmentally friendly - higher CO₂ emissions

Current	Potential
59	71

The potential rating shows the effect of undertaking all of the improvement measures listed within your recommendations report.
