Home Report

11 Riverside
Foyers Inverness IV2 6YH

single survey

Property address	11 Riverside Inverness IV2 6YH
Customer	Stewart Goodwin
Prepared by	Graham + Sibbald LLP

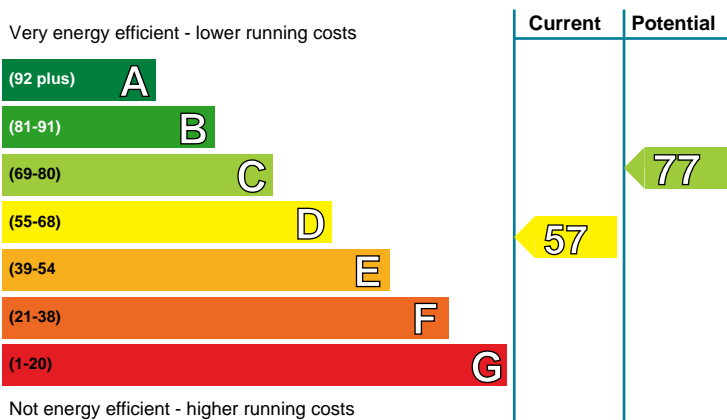
Energy Efficiency Rating

This graph shows the current efficiency of your home, taking into account both energy efficiency and fuel costs. The higher this rating, the lower your fuel bills are likely to be.

Your current rating is **band D (57)**. The average rating for EPCs in Scotland is **band D (61)**.

The potential rating shows the effect of undertaking all of the improvement measures listed within your recommendations report.

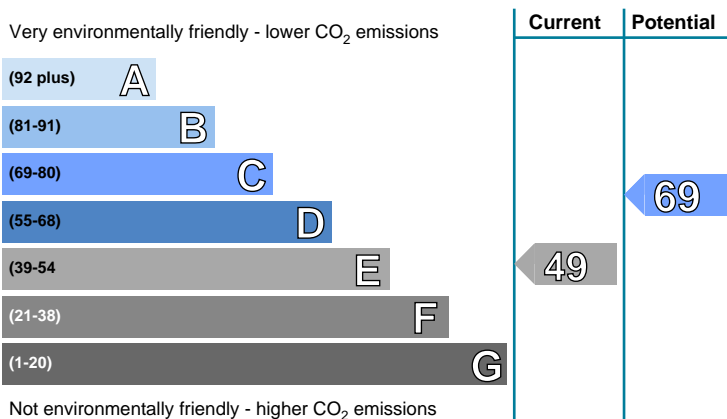
Environmental Impact (CO₂) Rating

This graph shows the effect of your home on the environment in terms of carbon dioxide (CO₂) emissions. The higher the rating, the less impact it has on the environment.
