YOUR ONESURVEY HOME REPORT

17 Holm Dell Court Inverness IV2 4GY PREPARED FOR

SINGLE SURVEY

17 Holm Dell Court, Inverness, IV2 4GY

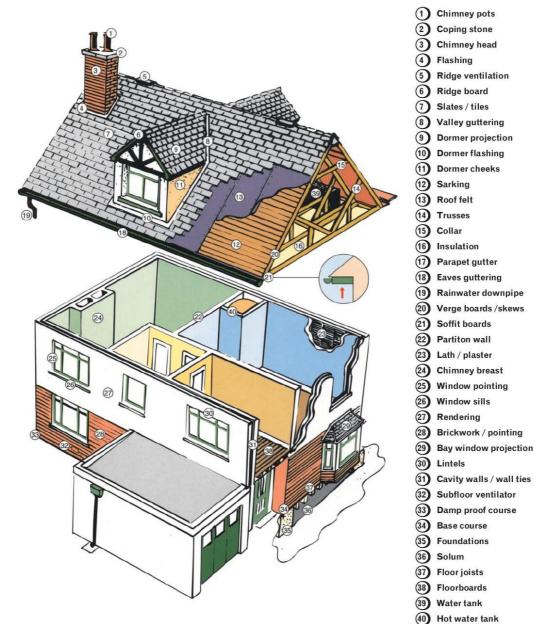
Sectional Diagram showing elements of a typical house

Reference may be made in this report to some or all of the above component parts of the property. This diagram may assist you in locating and understanding these items.

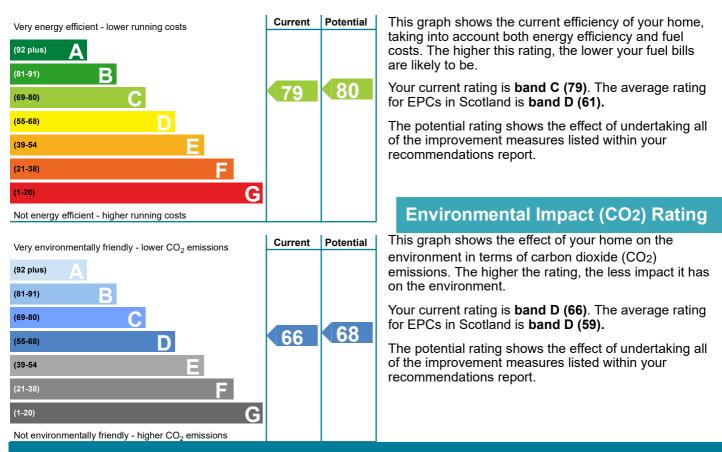
Energy Efficiency Rating	
Estimated energy costs for your home for 3 years*	£2,235	See your recommendations
Over 3 years you could save*	£135	report for more information

* based upon the cost of energy for heating, hot water, lighting and ventilation, calculated using standard assumptions
