# Home Report

8 REDWOOD CRESCENT  
INVERNESS  
IV2 6HB

**Walker Fraser Steele  
Chartered Surveyors**

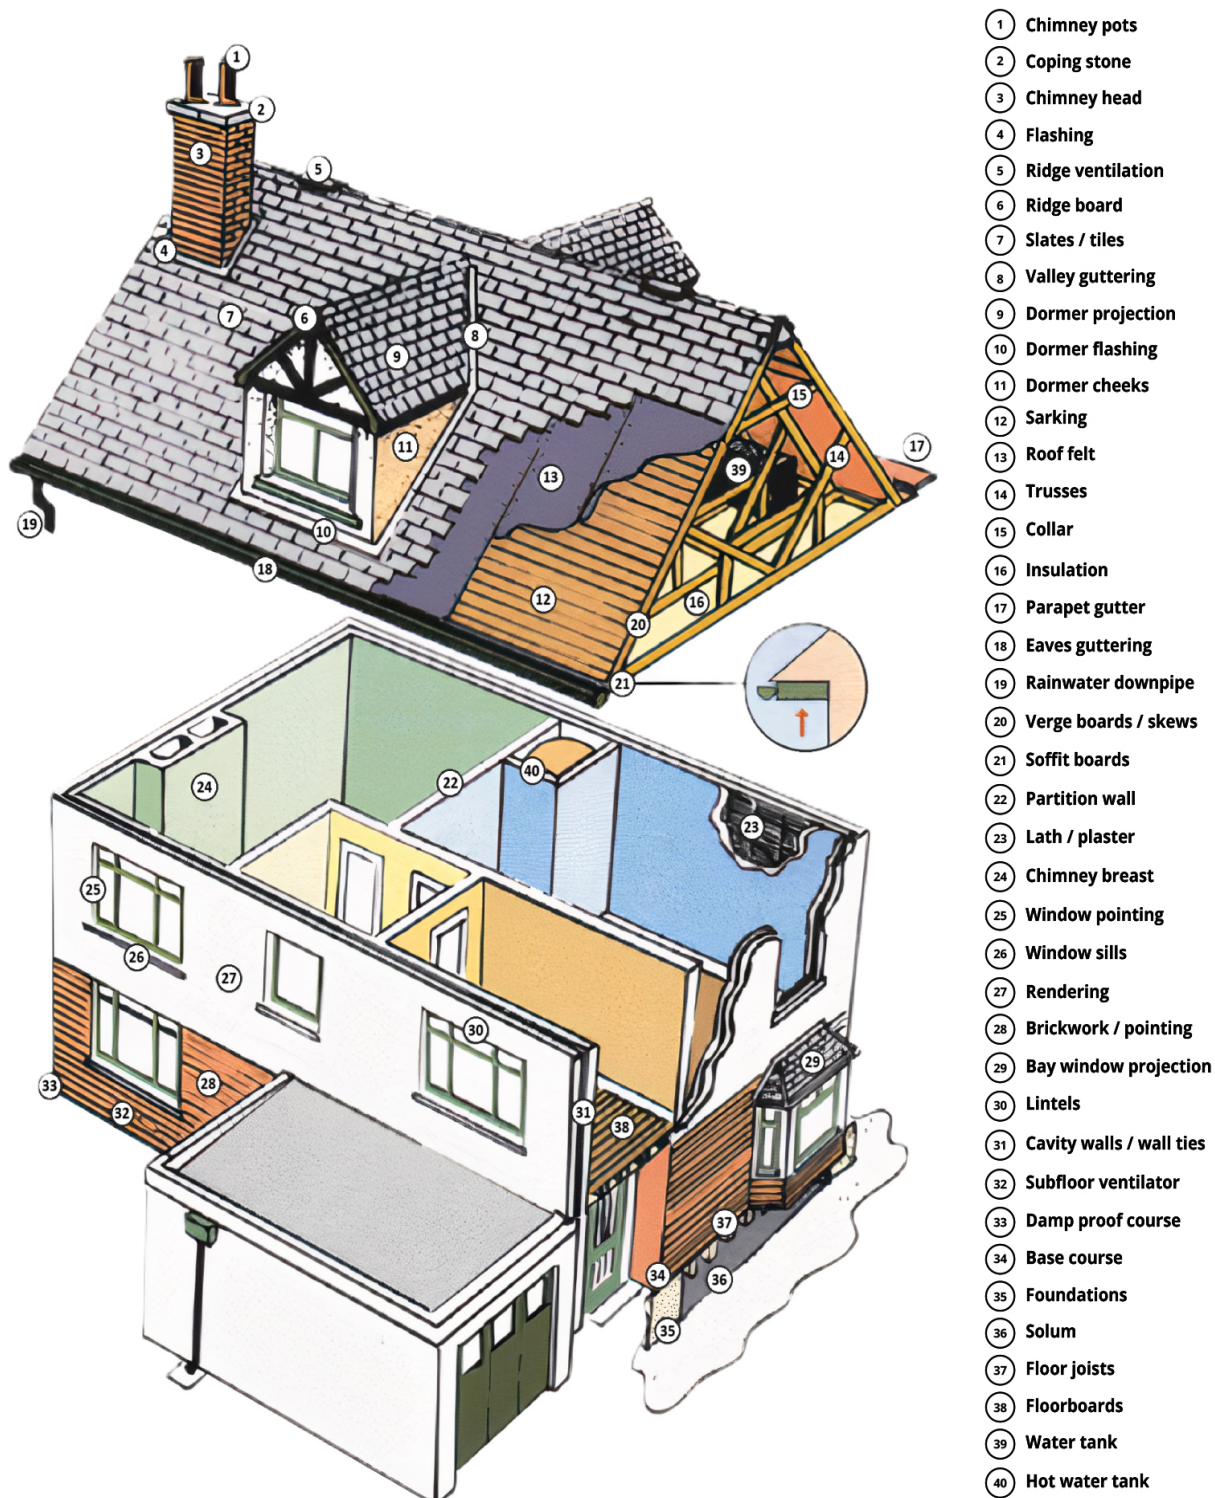
## Sectional Diagram showing elements of a typical house

Reference may be made in this report to some or all of the above component parts of the property. This diagram may assist you in locating and understanding these items.
