Greystanes Glaschoil,
Grantown-on-Spey,
PH26 3PR

Home Report

Single Survey

Property Address	Greystanes Glaschoil, Grantown-on-Spey, PH26 3PR
Reference	1238110
Customer Name	The Royal Bank of Scotland plc
Date of Inspection	26th September 2025
Surveyor's name, qualifications and office	Calum Riach MRICS DM Hall LLP Chartered Surveyors Hope House, Cradlehall Business Park, Castlehill Drive Cradlehall Inverness IV2 5GH Tel: 01463 241077 email: invernessresidential@dmhall.co.uk
Prepared By	DM Hall LLP

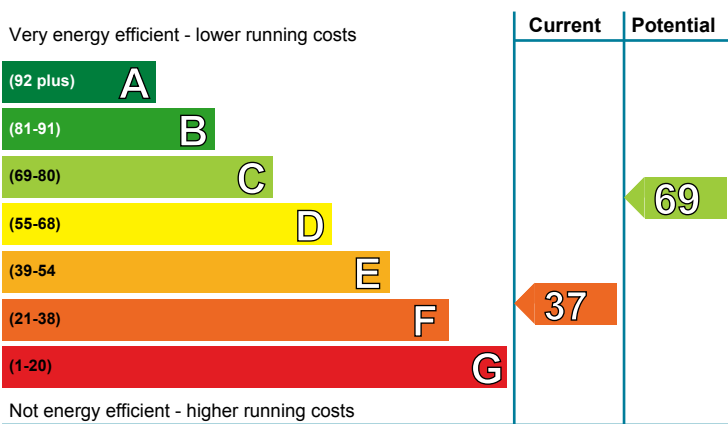
Energy Efficiency Rating

This graph shows the current efficiency of your home, taking into account both energy efficiency and fuel costs. The higher this rating, the lower your fuel bills are likely to be.
